Historic Preservation Commission Regular Meeting

2. Request for construction of storage sheds and fence - 701 W Hwy 50 SWCC (Local Landmark)

5CF.2896, 701 E. U.S. 50, Salida

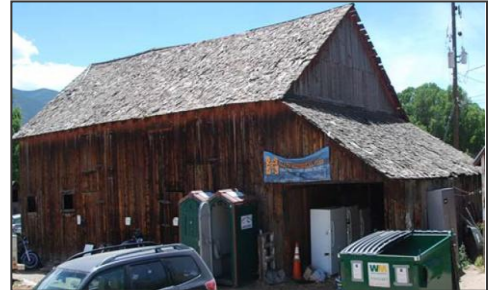
Photo of original barn

- The applicant is proposing to reutilize the barn wood, however the proposed locations of the new storage sheds does not reflect the historic layout of the agricultural property. The rear yard is used mainly for parking and storage of materials. A fence is also proposed to be constructed, which would further screen the view of the rear yard from public view.

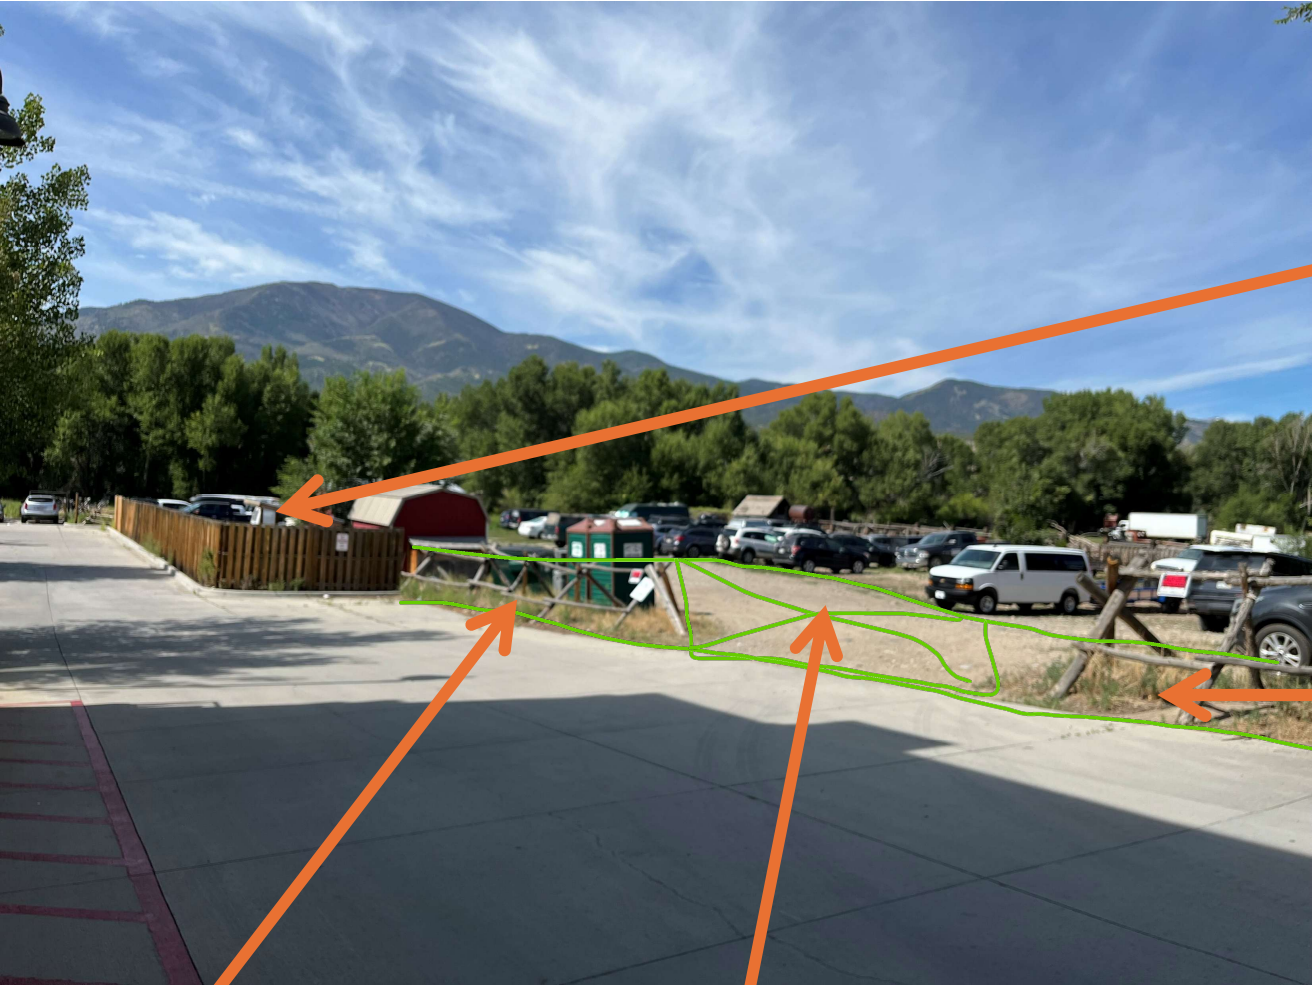
SCC Yard View – From Hampon Inn

Shed (Mark 9)
To be located
between
Existing sheds
and fencing

Fencing needed
to secure yard

Gate needed for vehicle access

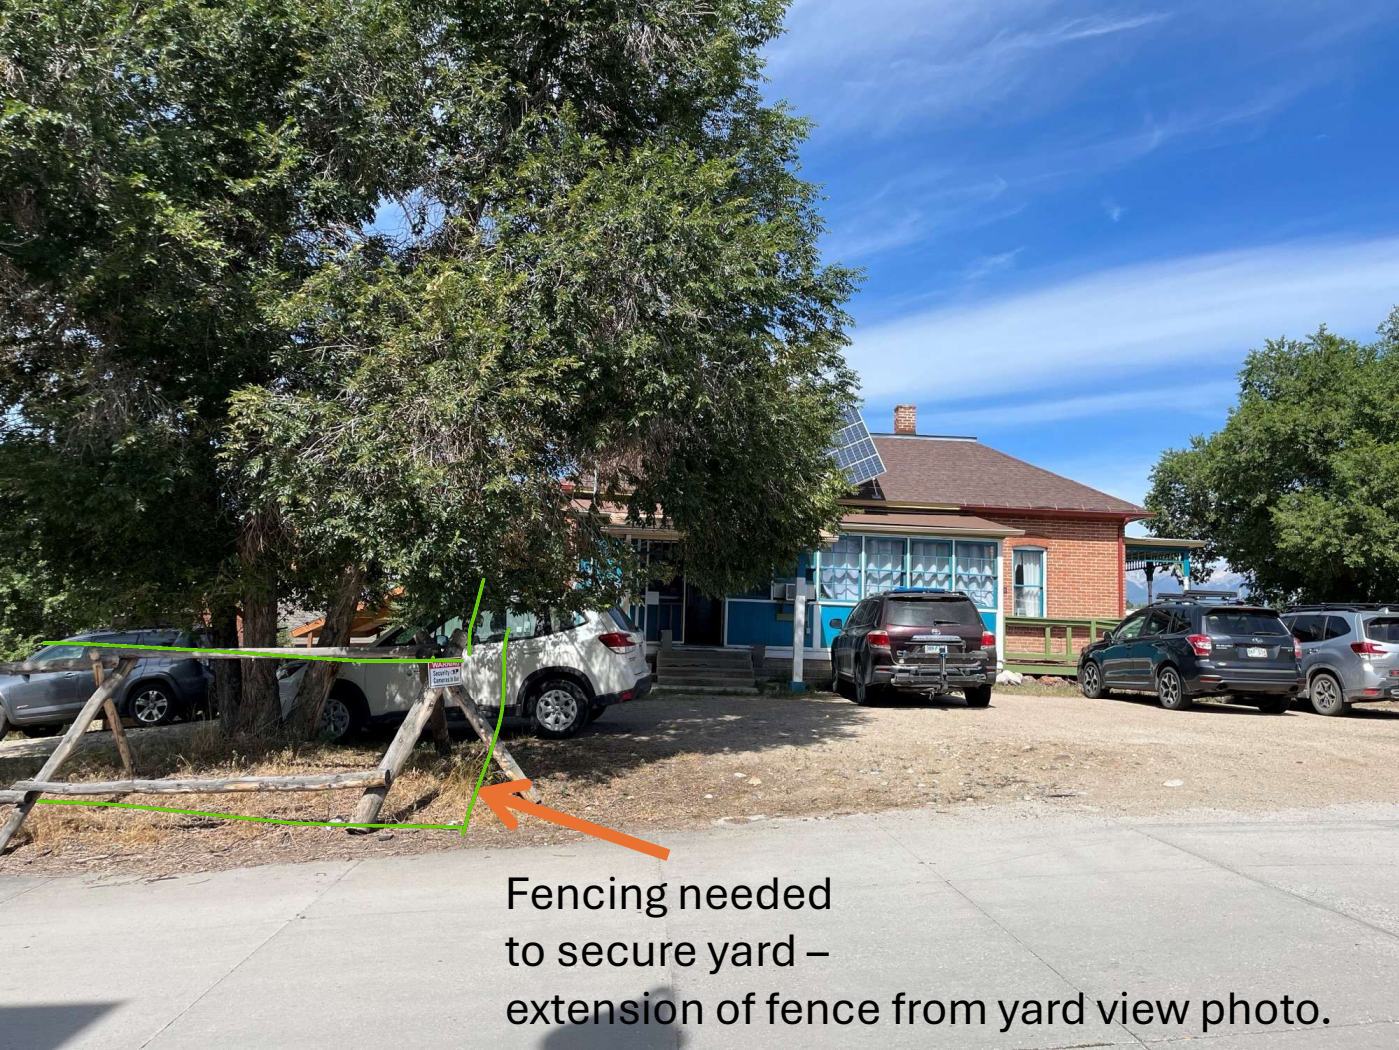
SCC House View – From Hampon Inn

Fencing needed to secure yard – extension of fence from yard view photo.

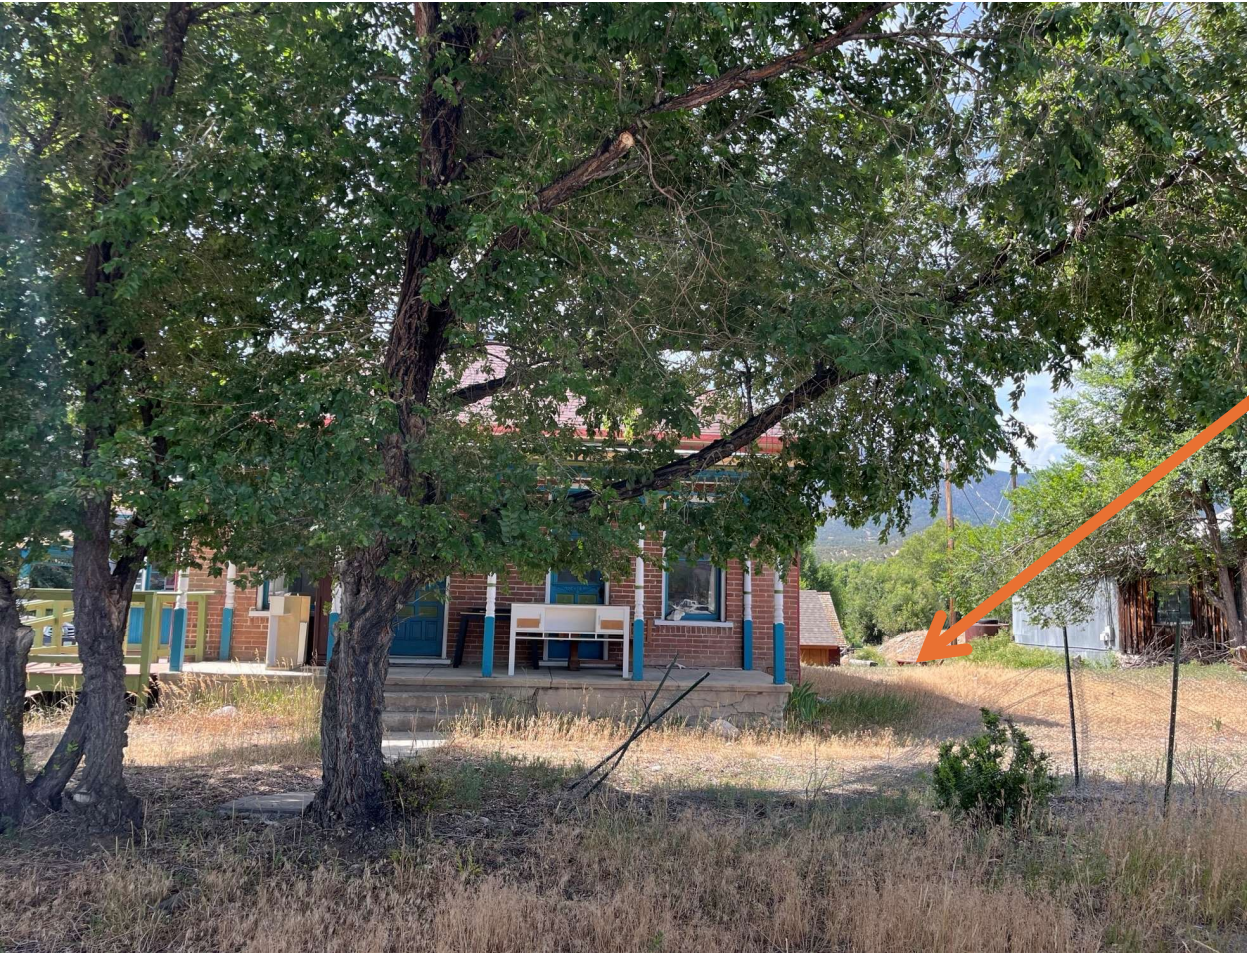
SCC House View – From Rainbow Blvd

Shed (Mark 10)
To be located
along side of
existing house.

Side of shed
facing road will
feature
barnwood only,
and no doors.

Once the shed is
in place there is
no need for a
fence in this
location.

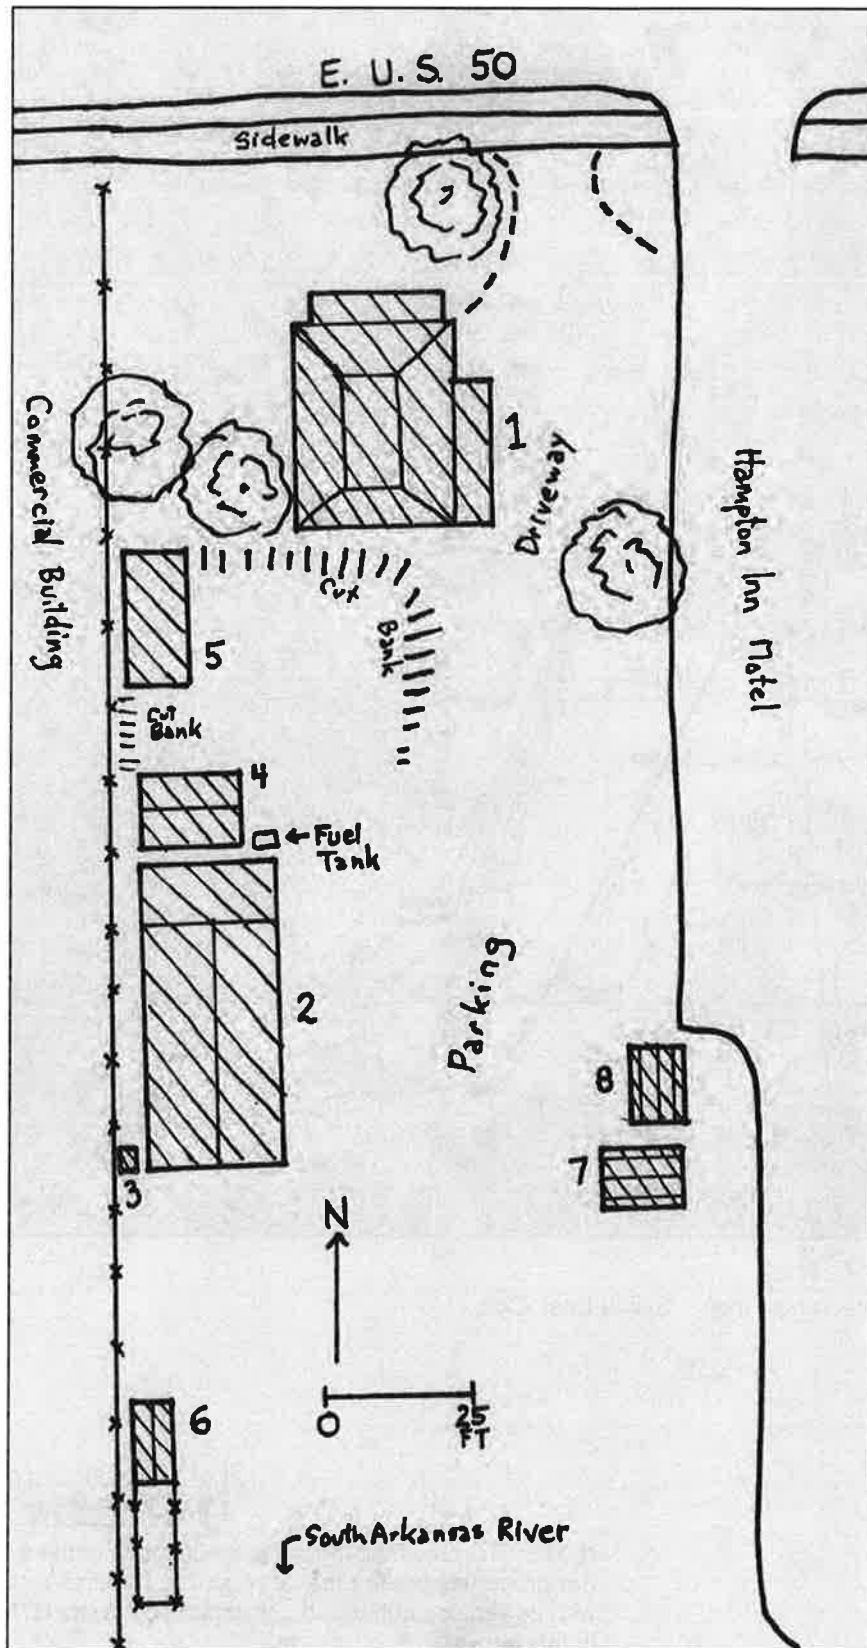
Architectural Inventory Form
Sketch Map

5CF.2896, 701 E. U.S. 50, Salida

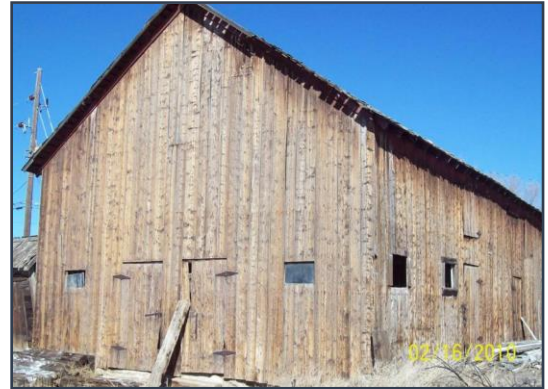
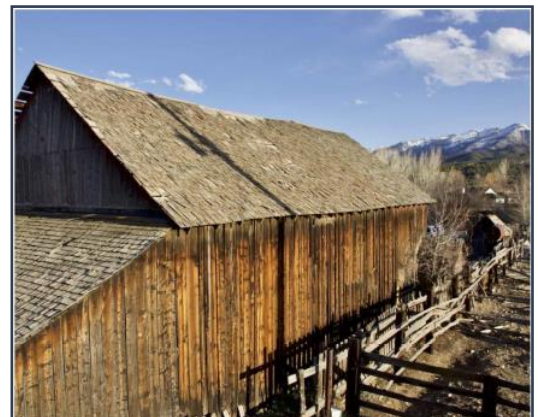
5. The barn is currently not a usable structure and poses a hazard as shown in the application materials. They are now having problems with squatters within the barn which is a liability to the SCC.

- The building has not been maintained for a number of years and there is extensive damage in the entire building which poses a safety issue for the owners and visitors of the property.

Based upon the observations and review standards outlined above, staff recommends **Approval** of the request for the demolition of the barn, a local landmark, located at 701 E. Highway 50 with the following conditions.

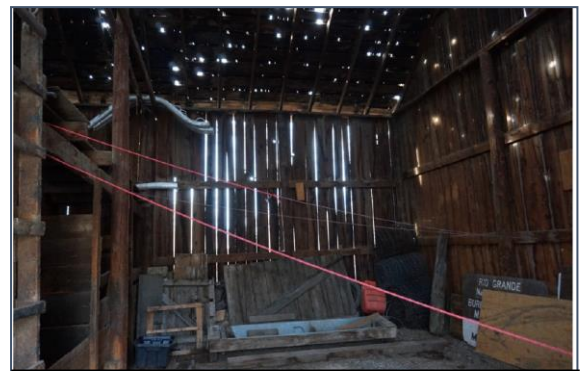
Interior photo from Historic structure assessment

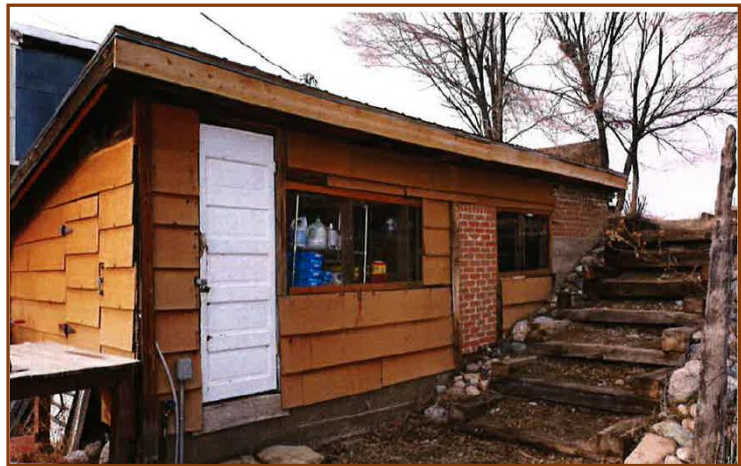
#5. Grain Shed, pre-1963, contributing. The rectangular one-story grain shed is built into the hill north and west (these walls are not visible). There is a concrete and stone foundation. The walls are sided with wide horizontal lap siding on the south half of the building; there is red brick on the north. There is a door on the south wall clad with wide horizontal siding that has strap hinges. The south end of the east wall has paired, center, two-light windows flanked by single-light windows; the north third of the wall has paired windows (one with two lights and one with a single light). The building has a shed roof with overhanging eaves covered with asphalt shingles and rolled roofing.

The south end of the east wall has paired, center, two-light windows flanked by single-light windows; the north third of the wall has paired windows (one with two lights and one with a single light). The building has a shed roof with overhanging eaves covered with asphalt shingles and rolled roofing.

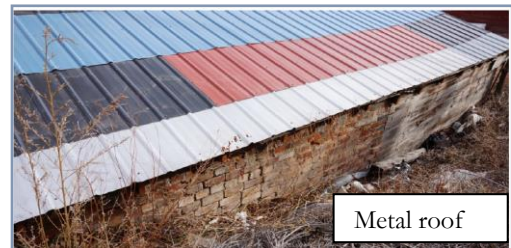
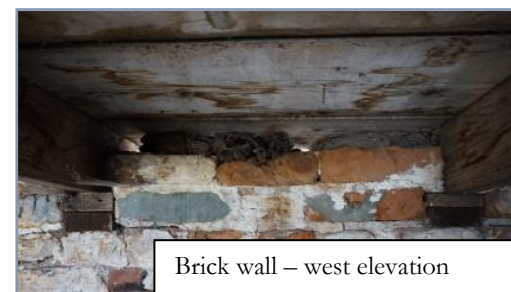
- Since the Architectural Inventory was completed a metal roof has been installed as shown in the application materials.
- In the Historic Structure Assessment the applicants refer to the grain shed as the Speakeasy, which according to the report has been altered significantly.

- The applicants received a State Historic Fund grant to have a structural assessment done on the entire property. The assessment for the grain shed showed that the structure has deteriorated almost beyond repair and has also been altered significantly.
- The report states that the condition of the walls and flooring systems are in poor to critical condition and to expect 75% to 100% replacement.
- According to the report the concrete foundation wall appears to be in good condition except at one location at the northwest corner where a large crack exists and extends up to the top plate

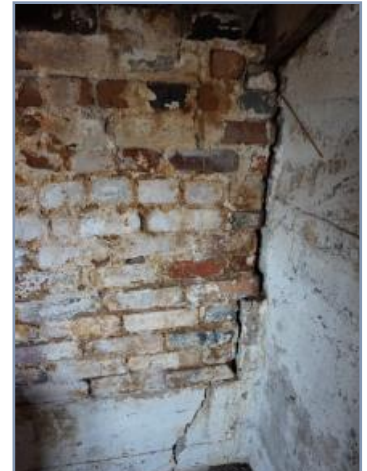
Crack in masonry wall
